# UNDERWATER FACILITIES INSPECTIONS & ASSESSMENTS

NAVAL AMPHIBIOUS BASE  
CORONADO, CALIFORNIA

FPO-1-84(20)

NOVEMBER 1984

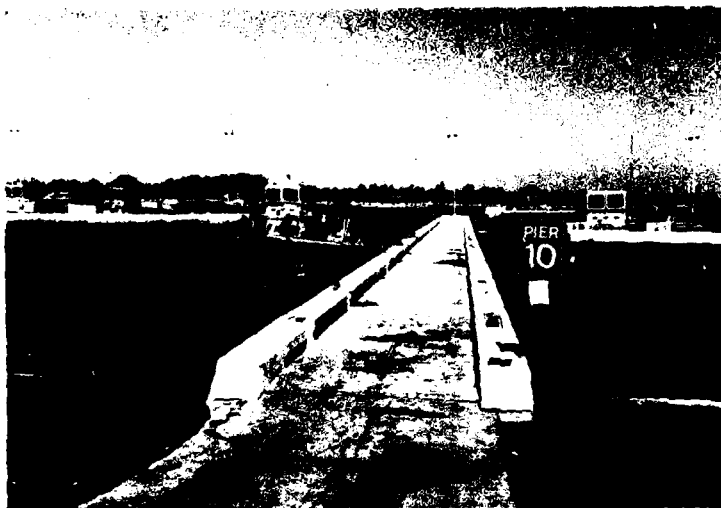
2. Pier 10. Pier is typical of the Piers 1 through 15.  
Picture is taken to the north.

It is recommended that the piles be inspected again in six years.

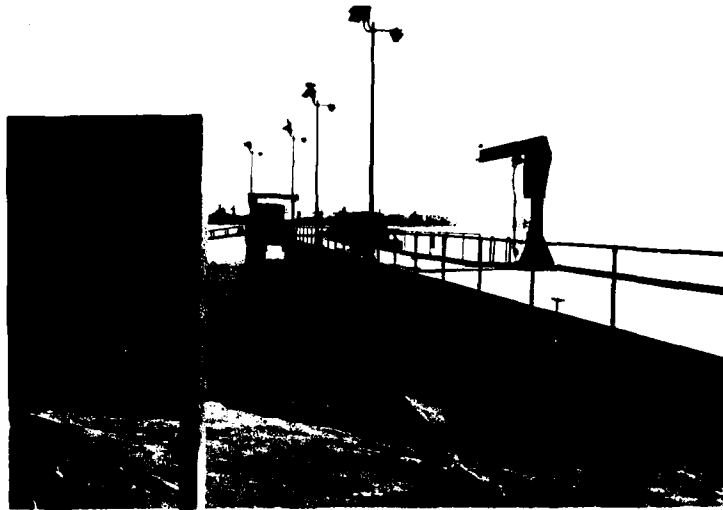
10. Mammal Pier. Photo taken to the east.

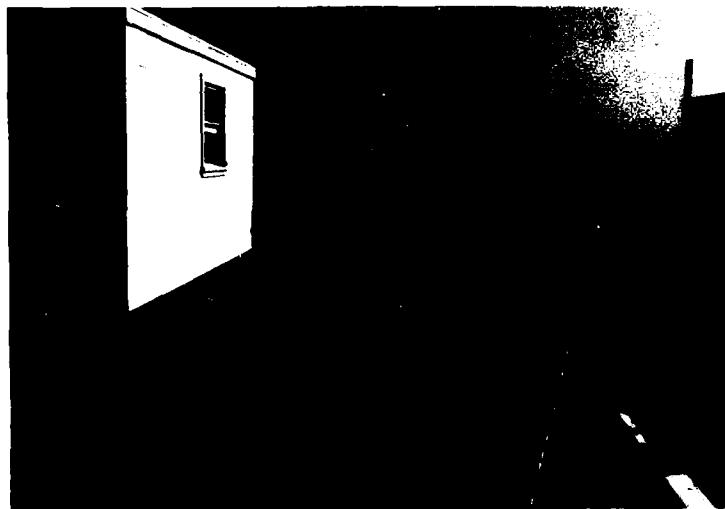
11. Mammal Pier. Picture is of eastern end platform.  
Southeast corner is at right.

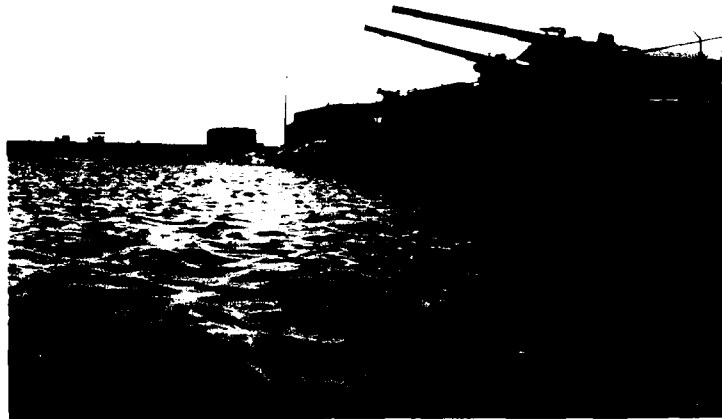
21. Bulkhead 1. View is to the east with Fuel Pier in background. Some cracking, spalling and rust bleeding is occurring to the tops of the precast panels.

It is recommended that continued attention be addressed to the repair of severe spalls when they occur to the Bulkheads and the Bulkheads be inspected again in six years.

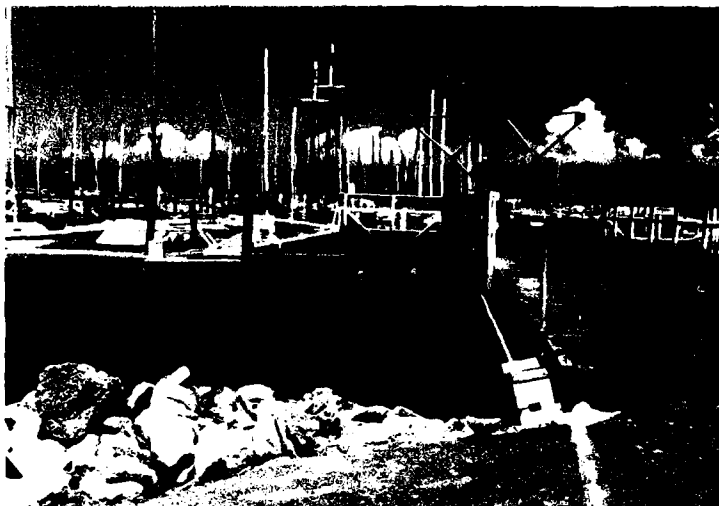
28. Marina, Pier 17. View is to the northeast of the fixed pier in the foreground with the floating piers beyond.
